APPENDIX 10B: CATALOGUE OF CULTURAL HERITAGE SITES (CHS) OF OBSERVED IN THE RIVER BANDON INSPECTIONS, CONDUCTED IN OCTOBER 2011/MARCH 2012

The catalogue of Cultural Heritage Sites of archaeological and architectural heritage interest observed in the course of the ADCO/JCA inspection surveys is presented below. A separate entry is given for each of the seventeen features recorded. The entries provide location and reference information, a basic description, and cartographic extracts where relevant. A site impact assessment categorized according to the parameters provided in Section 10.5 of this report is made, based on the project proposals of March 2012. Each entry is completed with outline recommendations to mitigate further archaeological work as necessary in light of these proposals.

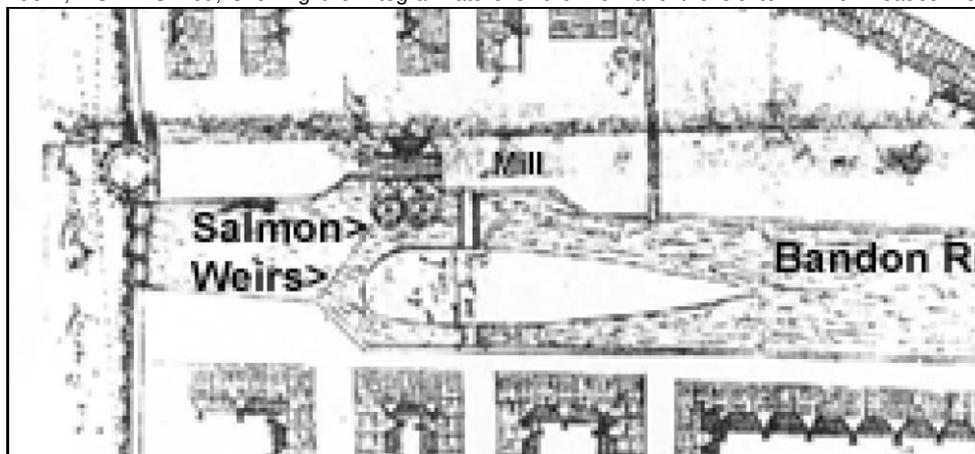
Detail from 'The plot of the towne of Bandonbridge for lo Carew', c.1620, based on the original in Trinity College Dublin, TCD MS1209, showing the integral nature of the weir and the old town. Downloaded from the website

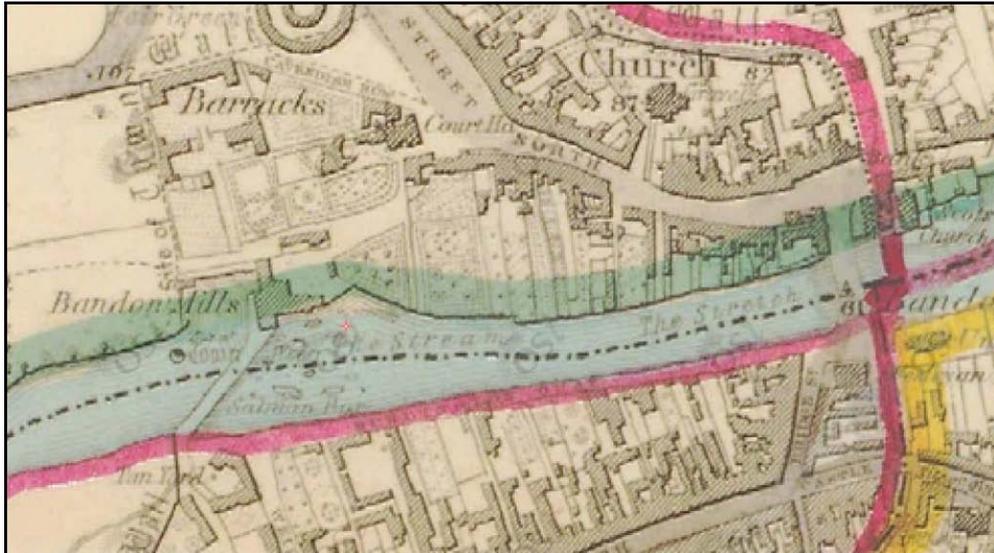
Detail from Ordnance Survey First Edition 6-inch series map showing the transformed nature of the river channel in Bandon by 1841, where the river island has been reduced to a shoals, the early mill site replaced by Bandon Mills, and the old salmon weirs more formerly constructed into the elaborate feature that stands today. Downloaded from www.osi.ie

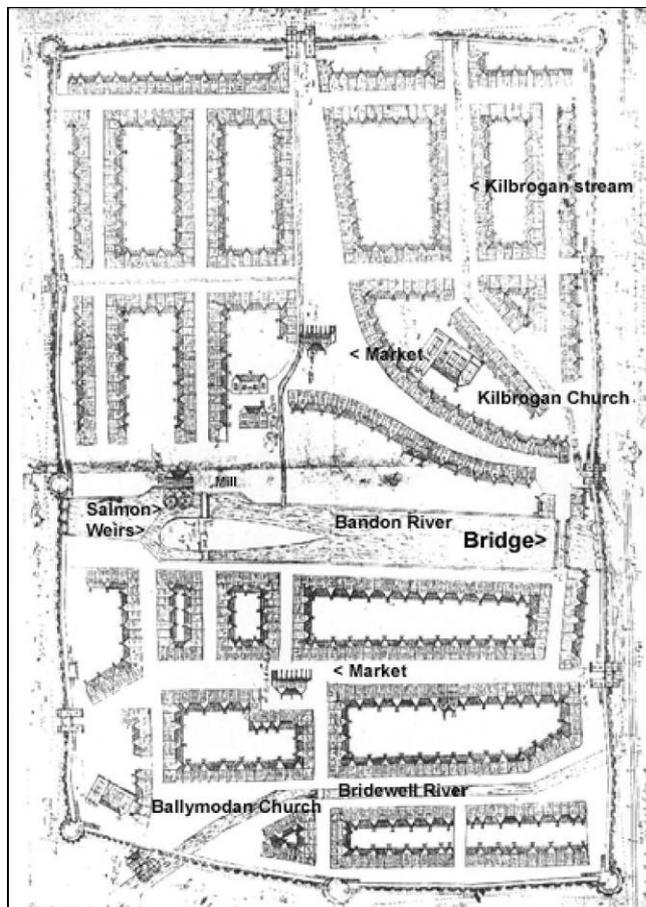
'The plot of the towne of Bandonbridge for lo Carew', c.1620, based on the original in Trinity College Dublin, TCD MS1209, showing the integral nature of the weir and the old town. Downloaded from the website www.paulturner.ca where the original map has been annotated.

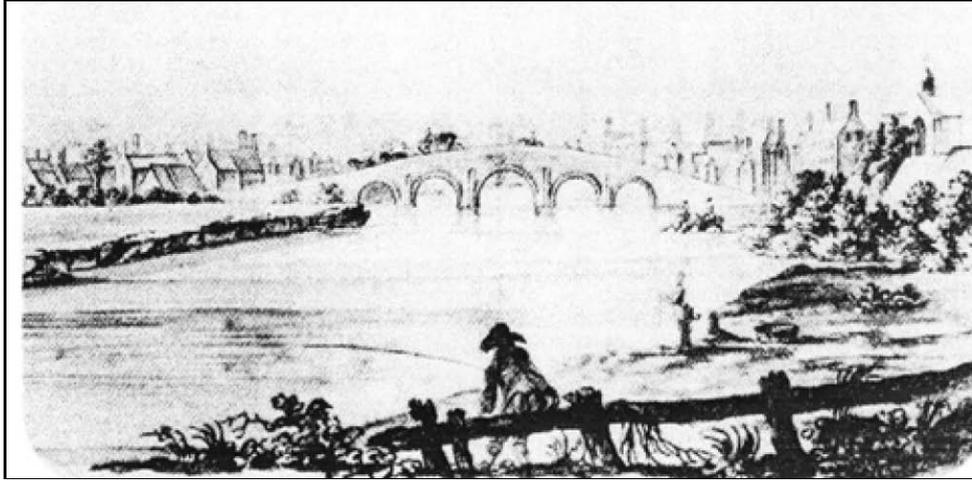
View of Bandon Bridge dated 1775, downloaded from www.paulturner.ca

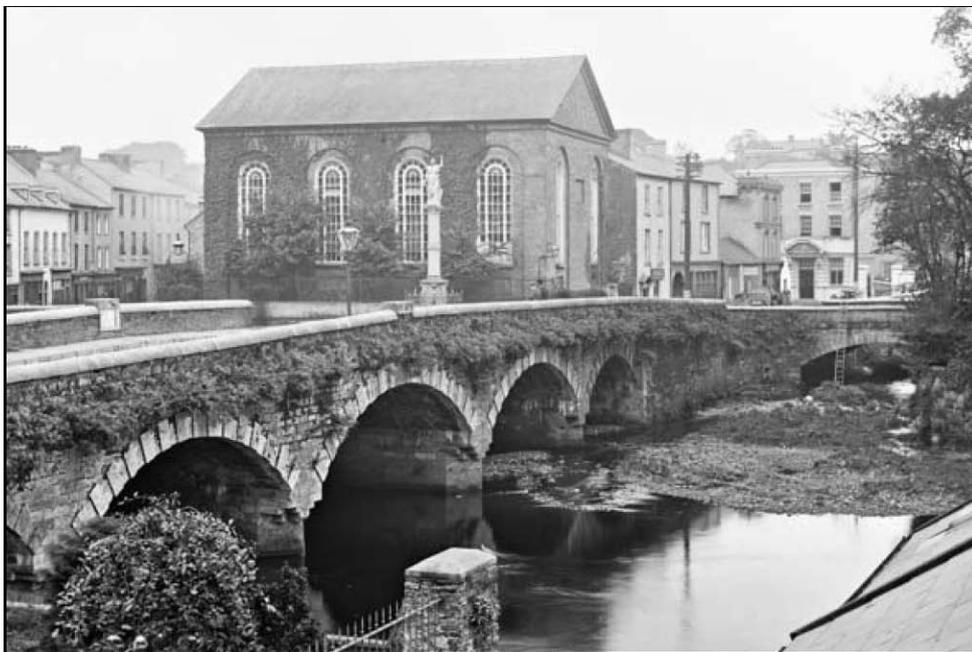
Photograph of Bandon Bridge in nineteenth century, from North, looking at the main bridge (Feature 004) from downstream, over to the footbridge (Feature 005). Source: National Library of Ireland, L_CAB_08849
